## SOUND URBAN FORESTRY, LLC

4/10/2023

RE: Tacoma Community College Gig Harbor Campus Tree Assessment

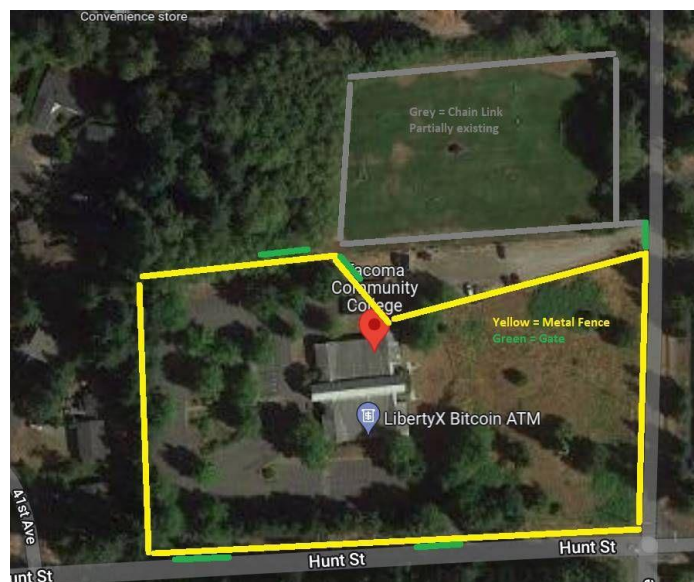
**Approximate Location of New Fence**

An assessment was conducted along the approximate new fence line as indicated on the provided aerial below. Based on this information and the spacing of the trees, no obvious conflicts were identified. However, besides stating the obvious of not placing any of the fence posts near the trunk a tree, without having the exact location staked out or knowing the intent of the contractor, it is difficult to make a final determination. Therefore, I would highly recommend that the location be staked and then either myself or a TCC representative walk the line with the contractor prior to any work, to review any potential conflicts and discuss ways to minimize any encroachment. This may include root pruning guidelines or a slight adjustment in the fencing location. Not only is the actual fence placement important but also the type of equipment to be used and where supplies will be stored.

I would encourage the College to establish communication with the fencing contractor prior to any work so that unnecessary impacts to adjacent trees can be avoided.

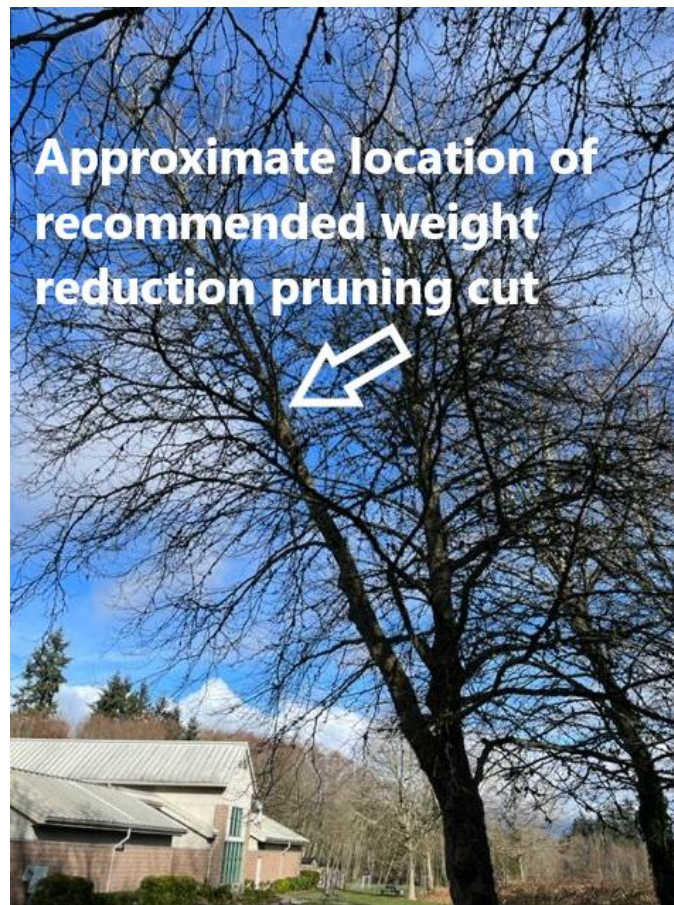
#### **Recommended Pruning of Tree #2**

**Tree #2:** London Plain Tree, 21" DBH. Approximate height of 60' and 30% live canopy ratio. This tree is in overall fair condition with no signs of decay or disease. The main trunk divides into co-dominant stems at 10' above grade with 2' of inclusion at the union. There are no signs of active separation but the weight at the union is concerning. Potential target is the entrance at 7'. Currently this tree is considered a "Moderate" risk.

**Recommendation:** I recommend that the co-dominant stem growing over the entrance be pruned to reduce the end weight. Approximately 8-10' of the upper stem should be removed, down to a lateral branch that measures 1/3 –1/2 the diameter of the section being removed (see photo). This pruning will lower the risk rating to "Low".

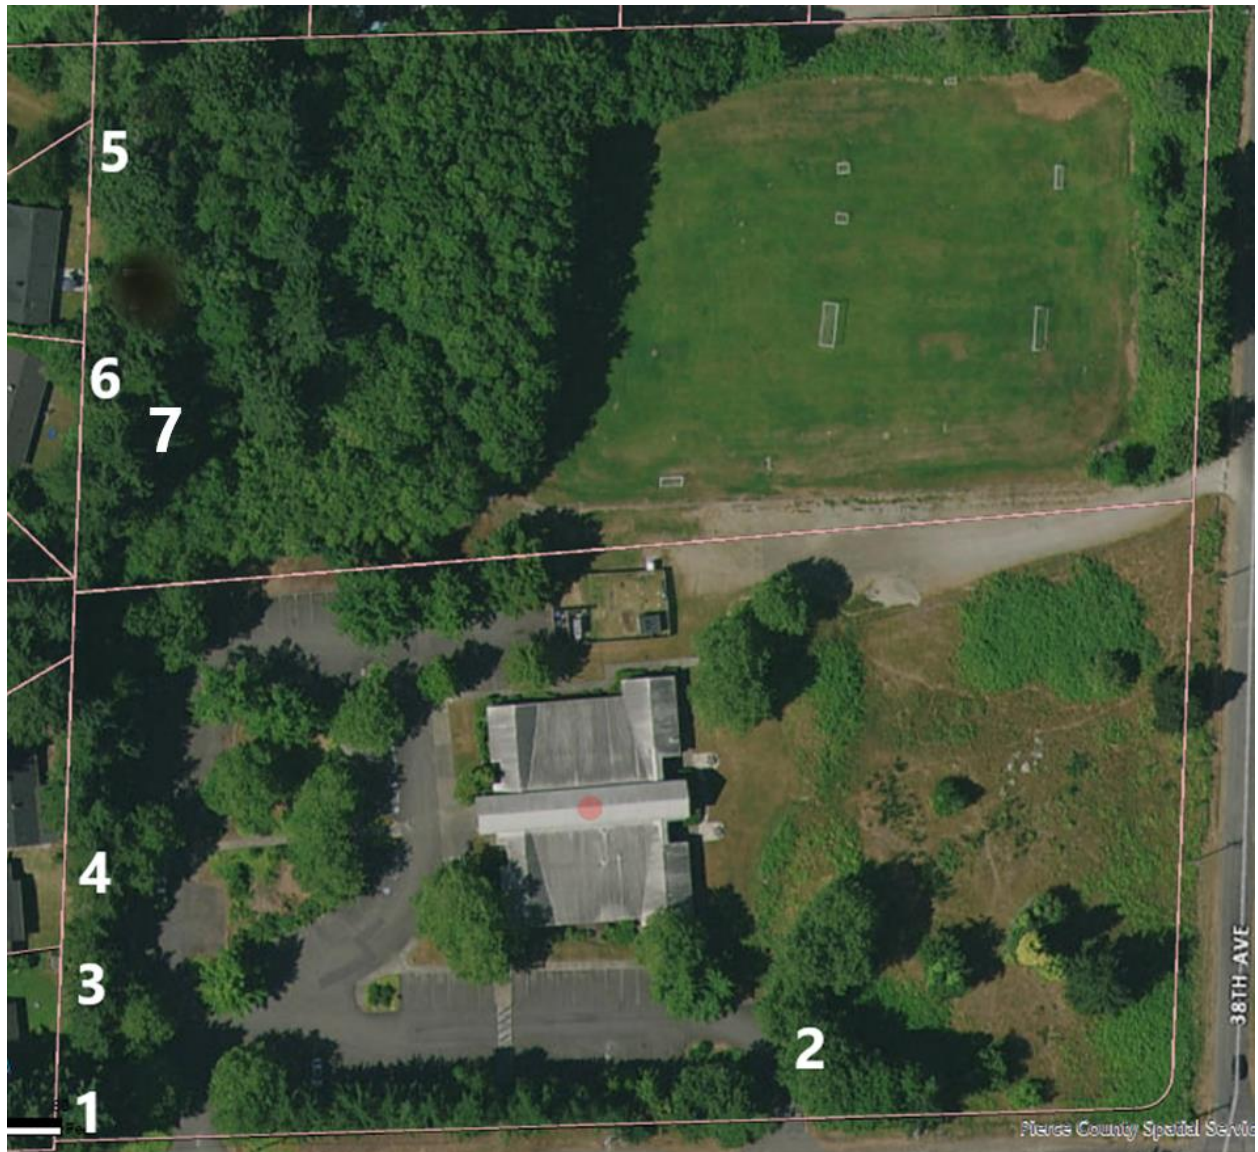
**Locations of Identified Risk Trees**

Level 2 risk assessments were conducted on all trees along the western perimeter with a potential target. A total of six trees were identified as of concern. Table 3 presents my complete findings and recommendations for these six trees. The approximate locations are noted on the included aerial and they have been marked with an aluminum tag indicating the corresponding ID#. Those trees recommended for removal have also been flagged with orange ribbon.

Tree ID#	Species	DBH (in)	Height (ft)	Live Canopy Ratio (%)	Target	Distance to Target	Condition	Comments	Risk Rating	Recommendations
1	Douglas Fir	34	120	20	Power lines, house, street	10', 26', 40'	Fair	Previously topped at 40' likely for utility line clearance. Co-dominant leaders above this point with 2' of inclusion Trunk soundings did not indicate internal stem decay but difficult to fully assess due to ivy.	Moderate	Retain but monitor. Cut ivy at base.
3	Western Red Cedar	11	40	0	Shed, fence	12', 10'	Dead	Two stems measuring 6" & 9".	Moderate	Remove tree
4	Western Red Cedar	11	45	0	Fence, yard	8', 8'	Dead		Moderate	Remove tree
5	Red Alder	21	40	0	Yard, swing set	12', 30'	Dead	Covered in ivy and lean toward adjacent property.	Moderate	Remove tree
6	Red Alder	32	65	25	Adjacent yards & houses	2', 10', 25', 36'	Poor	Three stems measuring 20", 18" & 18". Inclusion between the stems measures 3-4' with no signs of active separation. The 18" stem on the NW has decay at 20' associated with a past failure. All stems lean toward adjacent properties.	High	Remove tree

7	Red Alder	36	50	15	Yard	25'	Poor	Three stems measuring 22", 24" & 15". The 22" stem that leans to the west is dead and could reach yard. The 22" stem is tagged.	Moderate	Remove dead 22" stem.

I am recommending the removal of four trees and the pruning of two. All pruning should follow ANSI A300 (Part 1) 2017 Pruning Standards with no tearing, angled cuts or remaining stubs.
