## SOUND URBAN FORESTRY, LLC

8/7/2023

RE: Tacoma Community College Tree Assessment

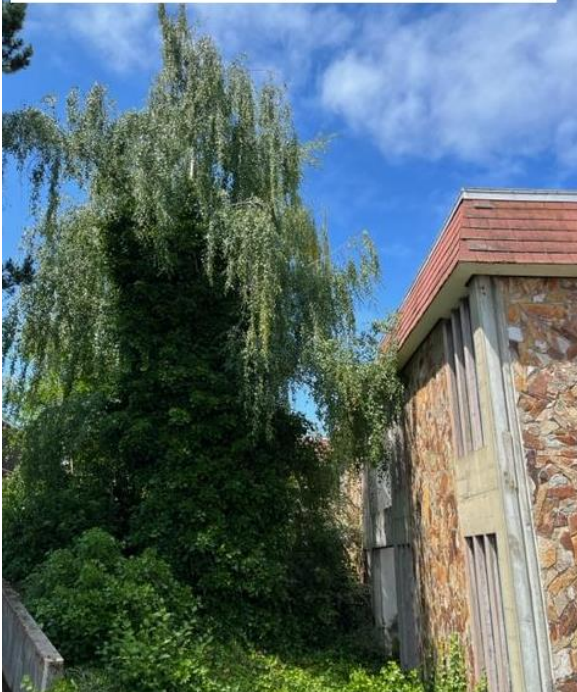
Tree ID#	Species	DBH (in)	Height (ft)	Live Canopy Ratio (%)	Target	Distance to Target	Condition	Comments	Risk Rating	Recommendations
9	Birch	14	45	20	Building	1'	Fair	Difficult to conduct complete assessment due to ivy. Branches are growing against building.	Low	Prune for clearance, cut ivy at base.
10	Birch	10, 8	30'	20	Building	4'	Fair	Branches growing against building. Ivy growing up stem.	Low	Prune for clearance, cut ivy at base.
11	Sweetgum	9	35'	25	Walkway	2'	Good	Base of trunk is lifting iron tree grates, tripping hazard.	Low	Remove grates
12	Black Locust	26	50	30	Sidewalk, street	5', 15'	Poor	Past co-dominant stem failure at the base revealed decayed bases of remaining stems. Fungal fruiting body also found.	High	Remove tree
13	Pacific Madrone	22	35	10	Walkway	20'	Poor	Tree is dying due to bacterial infection. Many dead limbs.	Moderate	Remove tree
14	Birch	14	30	5	Walkway	7'	Poor	Tree is in severe decline.	Moderate	Remove tree

**Tree #9 engulfed in ivy & touching building**

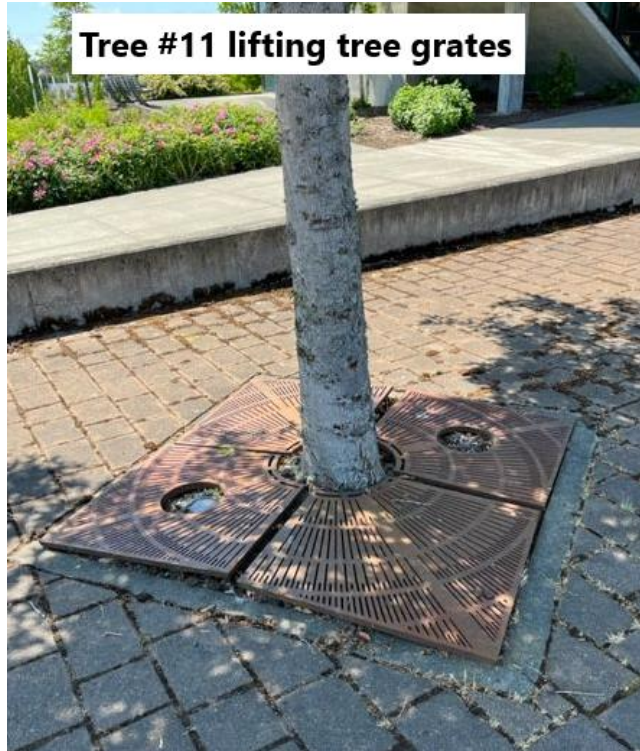
**Tree #11 lifting tree grates**

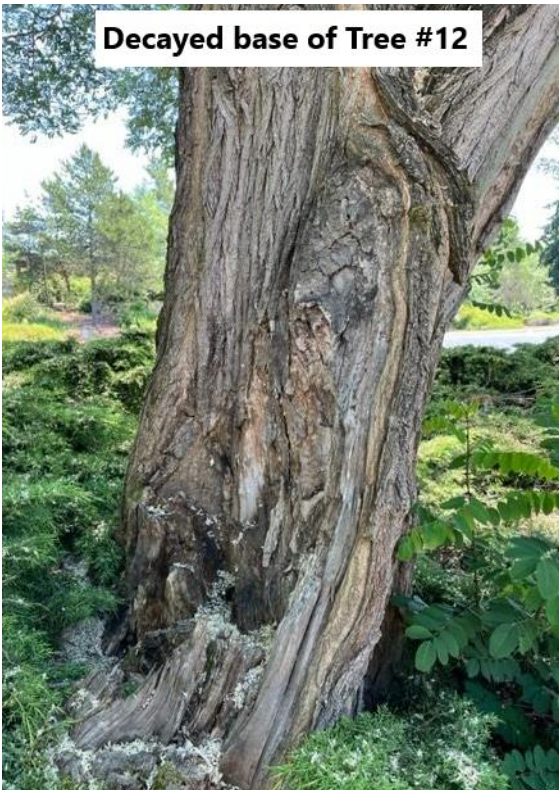
**Decayed base of Tree #12**

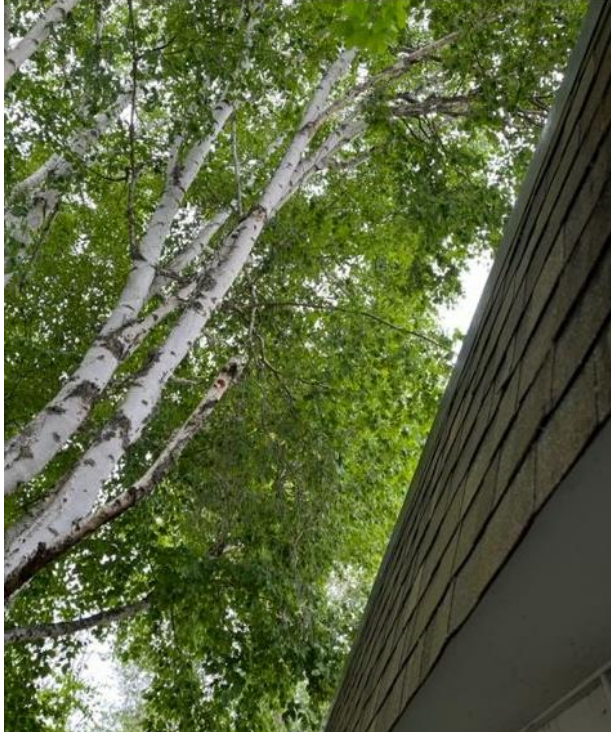
<b>Area</b>	<b>Description</b>	<b>Issue</b>	<b>Recommendation</b>
A	(16) 18-30" London Plane Trees (1) 21" Ponderosa Pine	Low branching over drive and parking lot.	Prune to raise crowns and provide proper clearance and visibility (12-14').
B	(2) 14-17" White Birch (3) 18-19" Norway Maple	Branches overhanging flat building roof, sidewalk and parking.	Prune to raise crowns and provide clearance and visibility.
C	Alder and willow	Low branches along 12 <sup>th</sup> Ave sidewalk.	Prune to raise crowns and provide pedestrian clearance.
D	(1) Multi-stemmed Vine Maple (1) 16" Douglas Fir (1) 17" Deodar Cedar	Blocking college signs and reader board.	Remove or reduce height of vine maple. Prune fir and cedar for sign clearance.
E	(3) 13-18" Scots Pine	Trees are located 2-4' behind walkway and roots are cracking & lifting asphalt by 1-3".	Remove trees or prune roots if walkway is to be repaired.
F	(7) 8-12" Purple Plums (1) 10" Cherry (8) 5-12" Norway Maples	Trees have been severely topped and are in poor condition. Structural integrity has been compromised.	Remove and replace trees

**Overhanging branches of Area 'B' Birch**

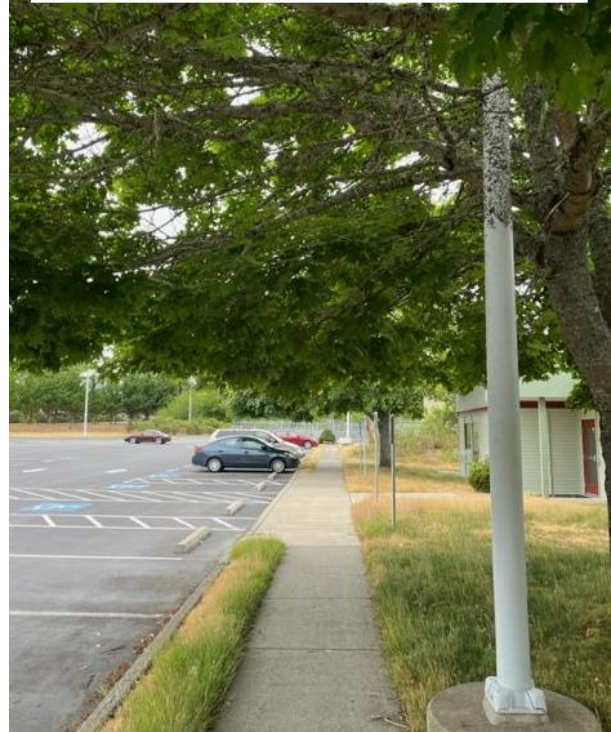
**Low branching of Area 'B' Norway maples**

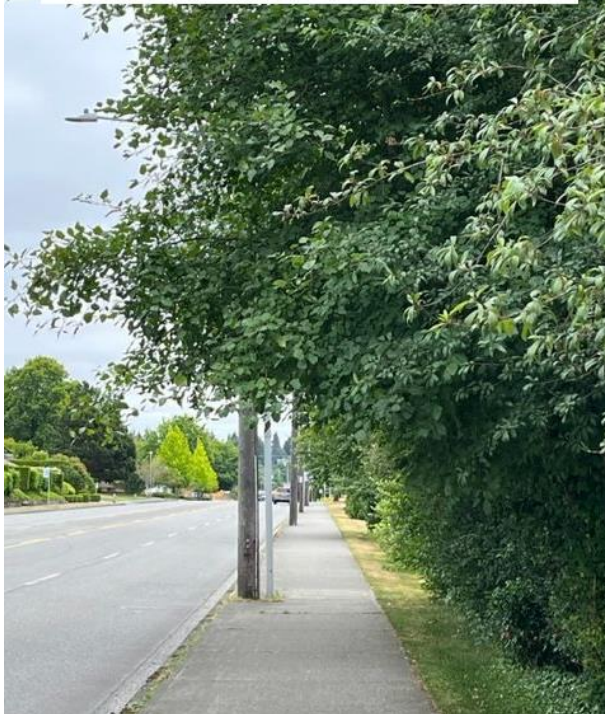
**Area 'C' branches overhanging 12th Ave**

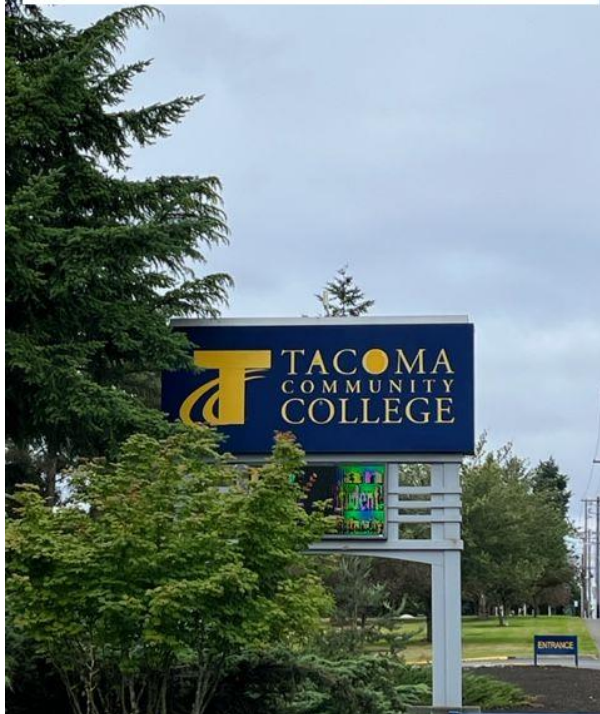
**Area 'D' branches encroaching College signs**

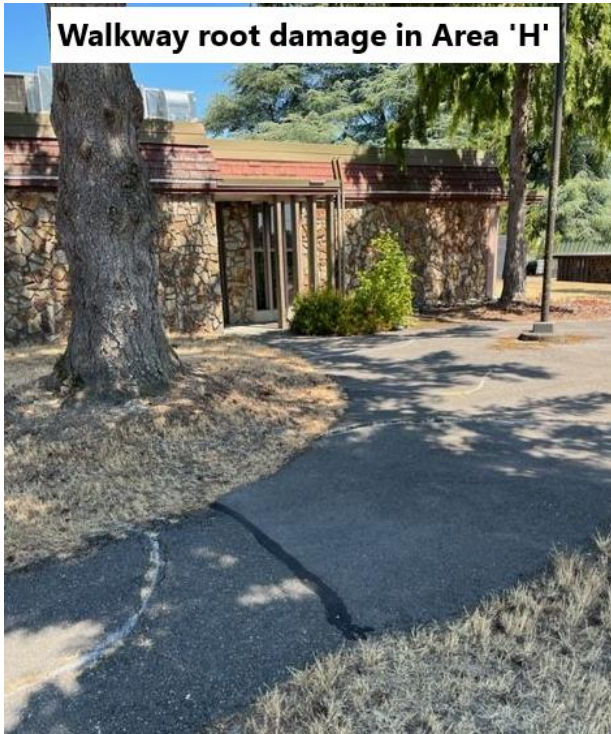
G	(2) 14-16" Red Maples	Roots are lifting asphalt walkway.	Remove trees or root prune if walkway is to be repaired.
H	(1) 25" Douglas Fir (1) 14" Port Orford Cedar	Roots are lifting asphalt walkway.	Remove trees or root prune if walkway is to be repaired.
I	(2) 2" Red Maples	One is dead, the other 25% dead.	Remove and replace with a different species.
J	(20) 4-9" Raywood Ash	Trees are behind Mildred St sidewalk and are blocking.	Prune to provide 8-10' of clearance.
K	(5) 8-10" Norway Maples	Trees have been topped and are in poor condition. Structural integrity has been compromised.	Remove and replace trees.

**Walkway root damage in Area 'H'**

Root pruning has been mentioned in many instances where the adjacent walkways are being lifted. While this is an option, tree removal is typically the preferred action as root pruning is considered a temporary solution and can be detrimental to the health and/or stability of a tree. It can be expensive and is an indication that the tree is the wrong species and simply too close to infrastructure. If it is decided to retain these trees, in order to avoid repeated problems, root barriers should be installed.

To lessen the impacts on the trees, root pruning needs to be applied correctly. If any roots >2" are exposed/disturbed, I recommend they be severed approximately 6-8" behind the edge of pavement/asphalt. Care should be taken to make clean cuts with a hand saw or pruners. Roots should never be torn with equipment. I can provide additional guidance on-site if needed.

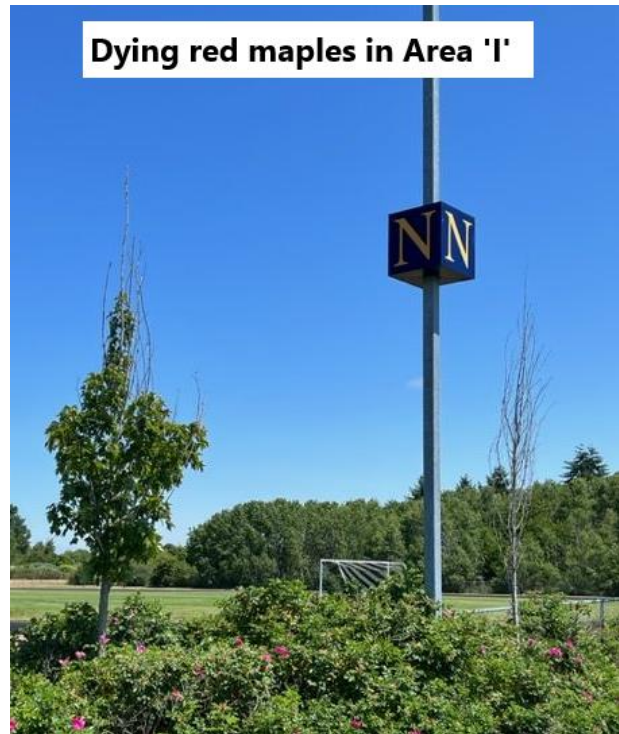
**Dying red maples in Area 'I'**

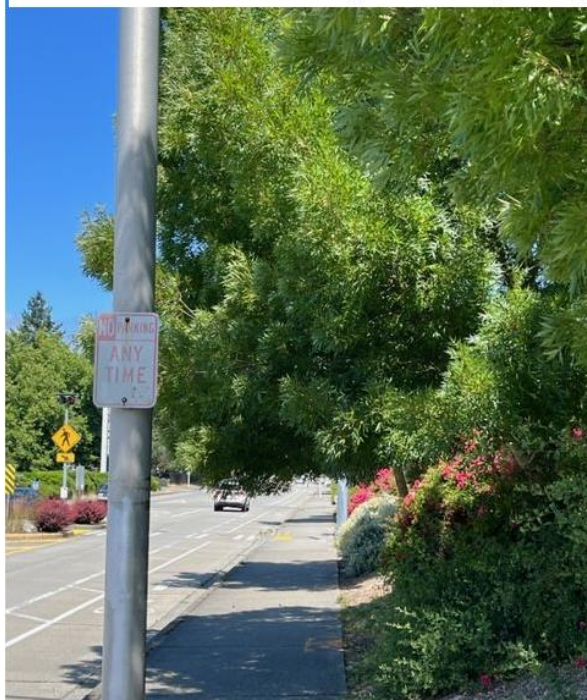
**Ash trees in Area 'J' needing clearance pruning**

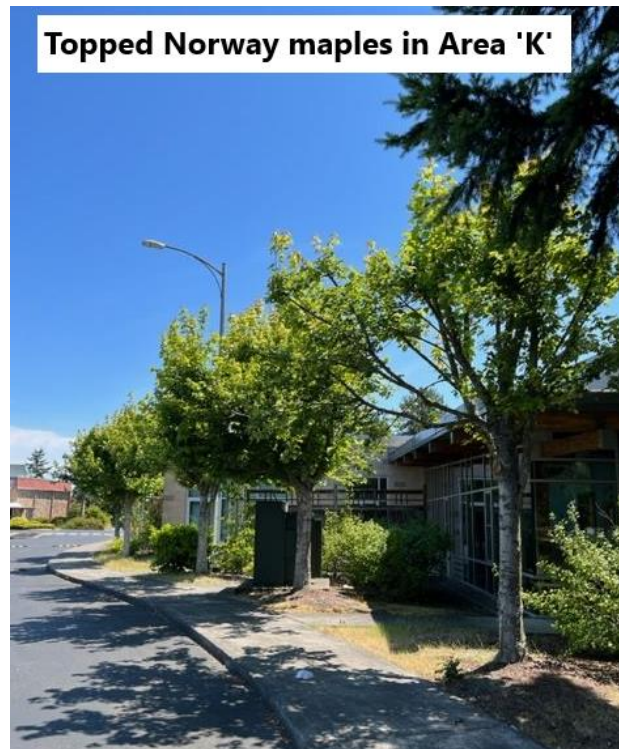
**Topped Norway maples in Area 'K'**
