SUF
SOUND URBAN FORESTRY, LLC

5/15/2025

RE: Tacoma Community College Gig Harbor Campus Tree Assessment

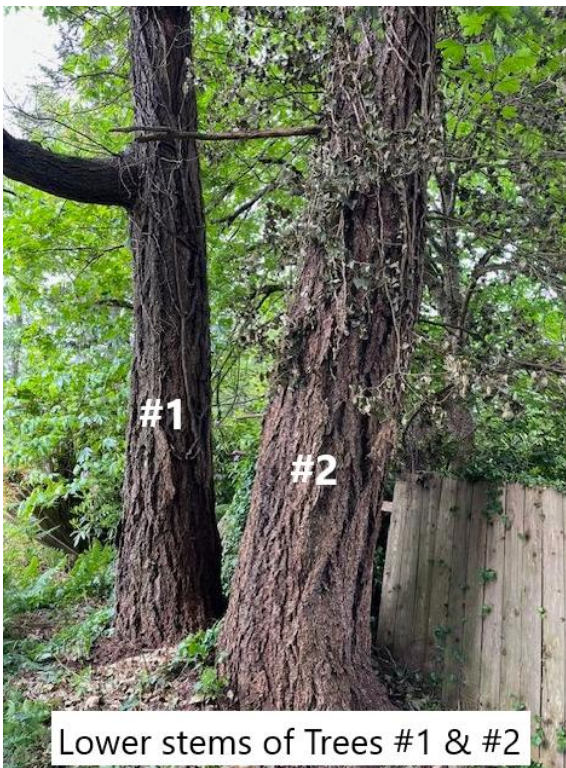
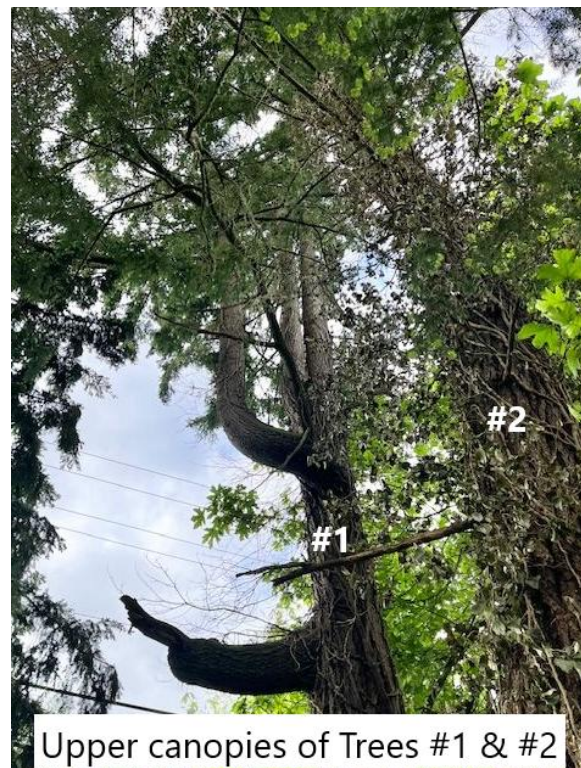
Photos

ID#	Common Name	DBH, Height, Live Canopy Ratio	Targets	Condition	Future Risk Rating	Comments/Recommendations
1	Douglas Fir	37" 125' 22%	Fence Road Powerlines Sidewalk House	Fair	Moderate	This tree was previously topped at 26'. A large diameter lateral branch originating from below this point along with two leaders originating from the topping cut attempted to establish dominance. The lower lateral was later topped at 31', which caused growth toward the east. The structure is poor but there is no target. There is approximately 12" of inclusion between the two leaders but no signs of active separation. Trunk soundings did not indicate internal stem decay but there is an exaggerated swelling at the butt log. Extracted core sample taken at 3' on the N side revealed 8" of solid holding wood. No indications of decay or disease. Retain tree
2	Douglas Fir	41" 130' 30%	Fence Yard House	Good	Moderate	Trunk soundings did not indicate any internal stem decay, no other signs of decay, disease or structural issues. Retain tree

I did not identify the need for any pruning or removal of trees along the shared property line with 6401. I recommend the trees be reassessed by a Certified Arborist in three years.
