SUF
SOUND URBAN FORESTRY, LLC

5/15/2025

RE: Tacoma Community College Gig Harbor Campus Tree Assessment

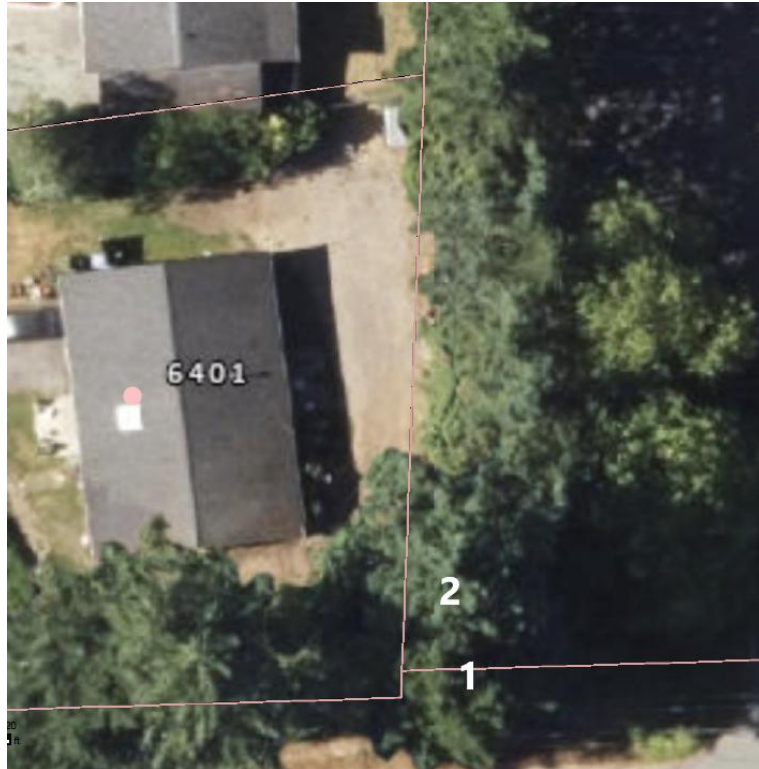
Locations of Trees in Table 3

ID#	Common Name	DBH, Height, Live Canopy Ratio	Targets	Condition	Future Risk Rating	Comments/Recommendations
1	Douglas Fir	37" 125' 22%	Fence Road Powerlines Sidewalk House	Fair	Moderate	This tree was previously topped at 26'. A large diameter lateral branch originating from below this point along with two leaders originating from the topping cut attempted to establish dominance. The lower lateral was later topped at 31', which caused growth toward the east. The structure is poor but there is no target. There is approximately 12" of inclusion between the two leaders but no signs of active separation. Trunk soundings did not indicate internal stem decay but there is an exaggerated swelling at the butt log. Extracted core sample taken at 3' on the N side revealed 8" of solid holding wood. No indications of decay or disease. Retain tree
2	Douglas Fir	41" 130' 30%	Fence Yard House	Good	Moderate	Trunk soundings did not indicate any internal stem decay, no other signs of decay, disease or structural issues. Retain tree

I did not identify the need for any pruning or removal of trees along the shared property line with 6401. I recommend the trees be reassessed by a Certified Arborist in three years.
